Lake Atalanta Park Restoration
Water Conservation Features: Pervious Pavers

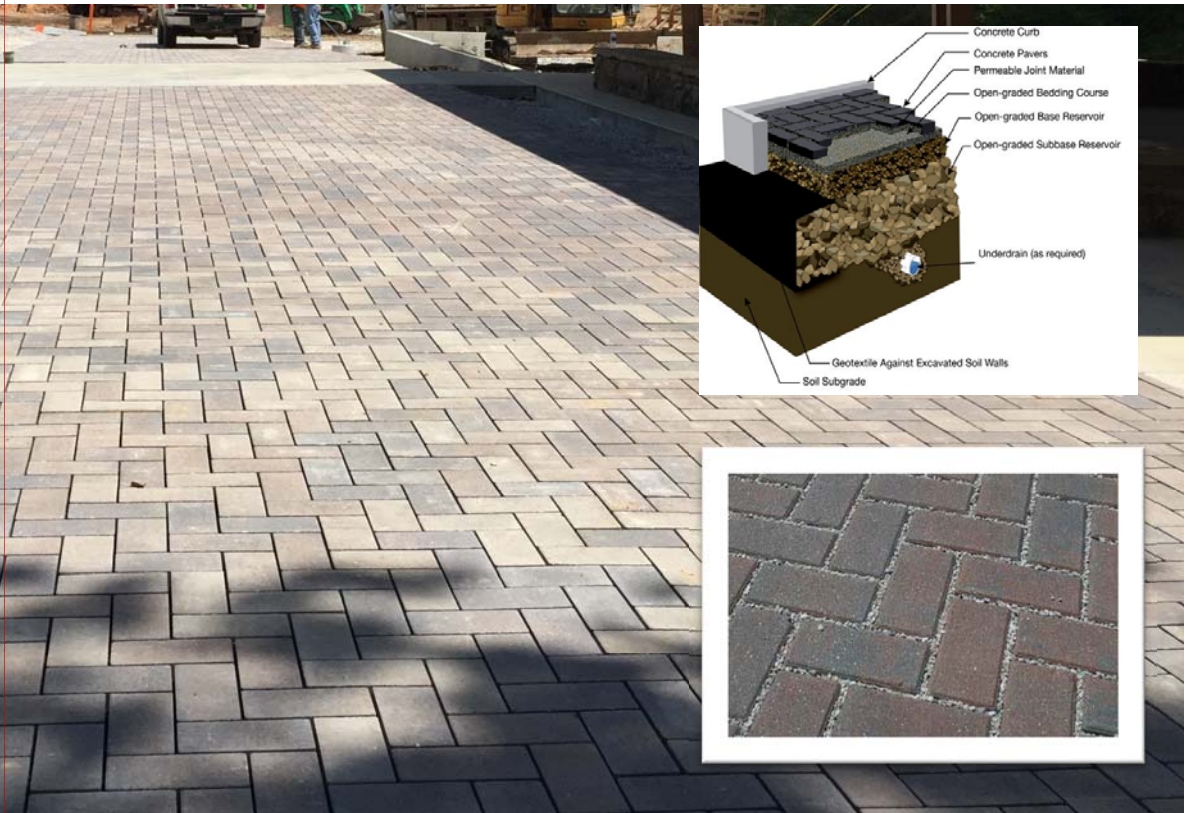
The new parking surfaces at Lake Atalanta Park, including the pavers at Clark Pavilion, reduce water pollution by allowing the rainwater to soak in between the blocks. The more than 4,000 square feet of pavers are supported by layers of coarse, angular gravel which interlocks and allows water to pass through it while supporting even the heaviest traffic.

The gravel and the soil beneath the pavers acts as a filter to remove contaminants through natural bacterial action and chemical processes. This filters out many contaminants rather than washing them directly into nearby Prairie Creek. Prairie Creek is one of the many tributaries that flow into Beaver Lake, a major recreation area and drinking water source for Northwest Arkansans.
